## Surgical and Prosthetic Treatment of a Failed Maxillary Central Incisor

Immediate implant placement is a key to success

Robert A. Levine, DDS, FCPP, FISPPS

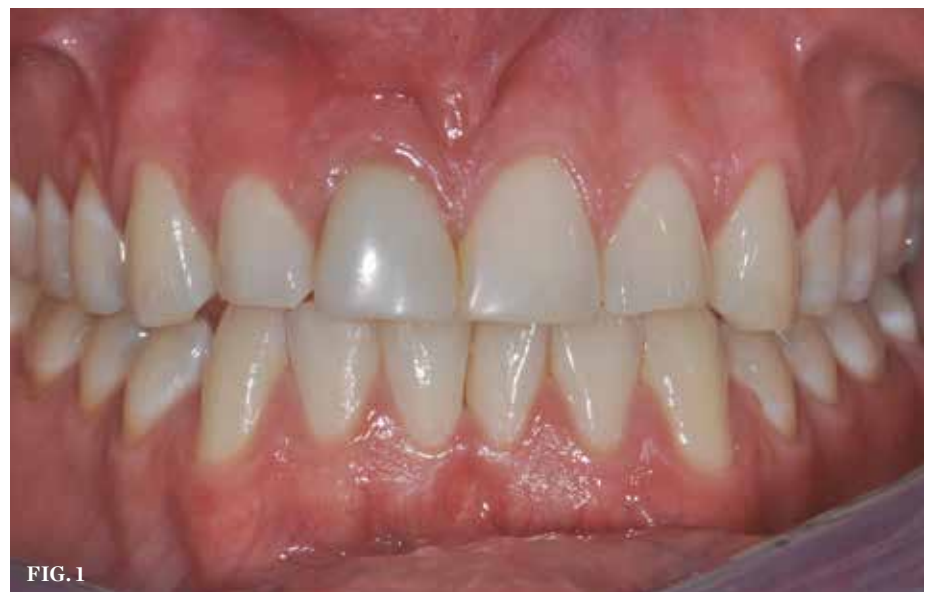
FIG. 1

(1.) Pretreatment diagnostic retracted clinical view.

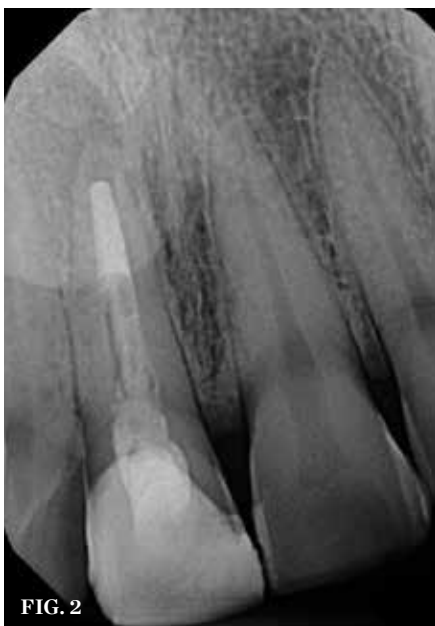
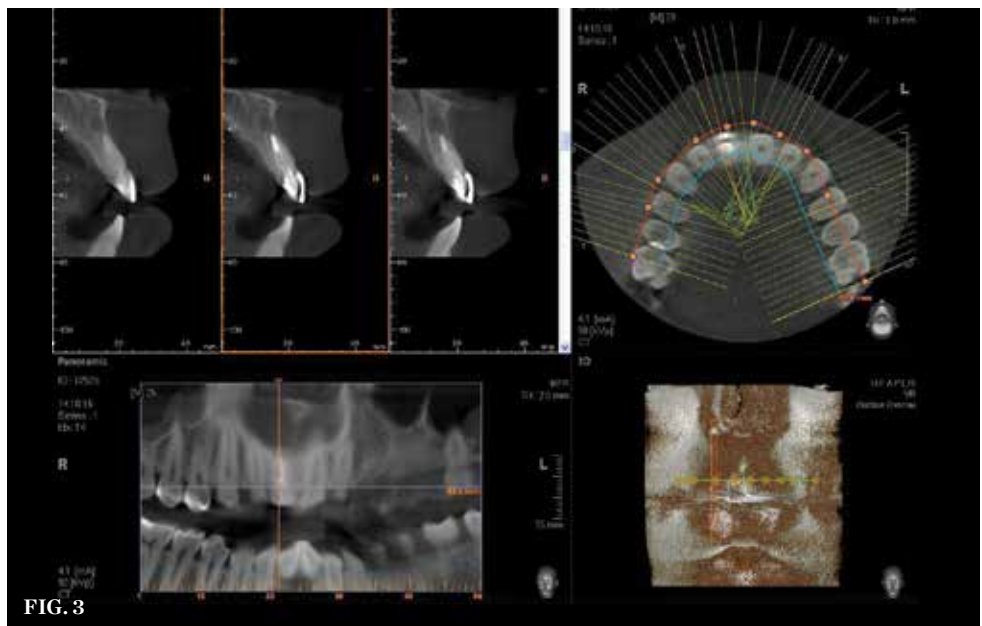
FIG. 2

A healthy 26-year-old, non-smoking man (ASA 1) presented in November 2014 complaining chiefly of discomfort apically in the area of tooth No. 8, which had a prior root canal treatment resulting from a traumatic event to the face (Figure 1 through Figure

3). A full-mouth periodontal examination revealed minimal to no bleeding on probing depths greater than 3 mm. The patient was aware that No. 8 was hopeless due to a chronic periapical lesion and was interested in permanent tooth replacement. He presented with high esthetic expectations, a medium lip line and gingival biotype, and slightly triangular-shaped maxillary anterior teeth (Table 1).<sup>1-4</sup>

(2. AND 3.) Pretreatment diagnostic radiograph and CBCT.

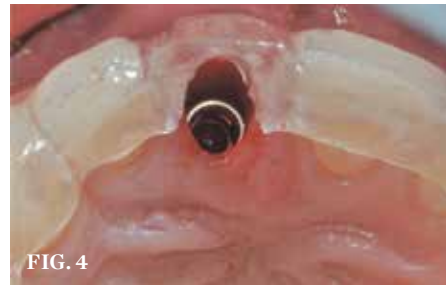
FIG. 4

(4.) Position of the buccal implant shoulder 1 mm deeper than the buccal height of bone. (5.) After flapless placement, a buccal gap of 2 mm was measured. (6.) Healing cap placed to support the soft-tissue graft. (7.) Screw-retained provisional 3 weeks postplacement. (8.) No. 8 final crown, 6 months post-placement. (9.) Favorable buccal contours simulating the adjacent natural tooth. (10.) Final periapical x-ray. (11.) Final smile.

wall where the abscess was removed, resulting in a fenestration without a fistula. A Straumann BLT Roxolid SLActive 4.1-mm x 14-mm implant was installed using the rules for 3D placement per the *ITI Treatment Guide, Volume 1*.<sup>1</sup> This was done with the aid of the anatomically correct surgical guide template—placement was along the palatal wall and in an apical position of 4 mm below the mid-facial position of the surgical guide (Figure 4). Because the coronal buccal wall was totally intact and soft tissue measured 3 mm mid-buccal, the position of the buccal implant shoulder was 1 mm deeper than the buccal height of the bone (Figure 5).

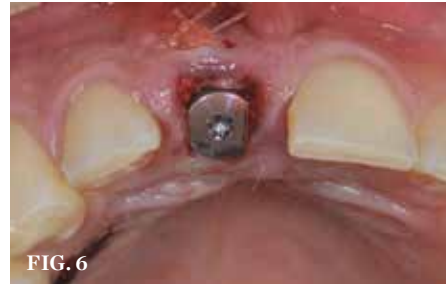
FIG. 6

A palatal soft-tissue connective tissue graft (CTG) was harvested from the Nos. 4 and 5 site. The CTG was placed and sutured under the partially elevated buccal flap from the mesiobuccal to distobuccal line angles and, apically, approximately 10 mm to further aid in long-term soft-tissue contours. This was done to mimic the root eminence of the extracted tooth and to act as a membrane to aid in guided bone regeneration of the buccal gap (Figure 6). In addition, the CTG changed the periodontal biotype from medium to thick (ie, biotype conversion).<sup>6-8</sup> A 7-mm tapered RC healing cap (Straumann) was placed to lightly support the soft-tissue graft and beveled to the level of the palatal tissues to prevent transmucosal loading by the tongue (Figure 6).

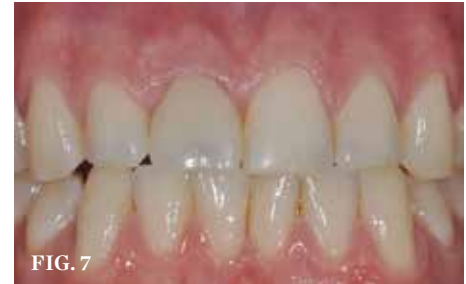
FIG. 7

The patient was seen in the author’s office 3 weeks after placement of the provisional to evaluate soft-tissue healing and tissue support and for a periapical x-ray (Figure 7). Based on clinical healing and the gingival margin being slightly apical for the No. 8 implant compared to the No. 9 natural tooth, further mid-buccal support with acrylic was recommended. The adjacent papillae were healing as expected and the patient was pleased with the results at that point.<sup>9</sup>

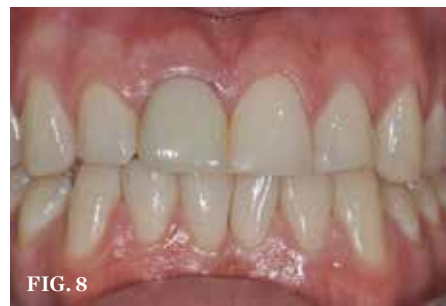
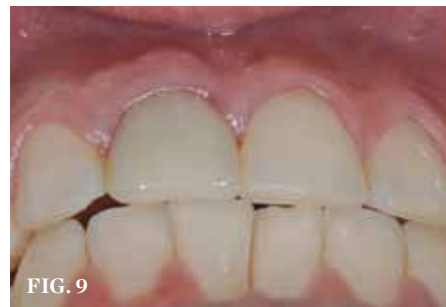
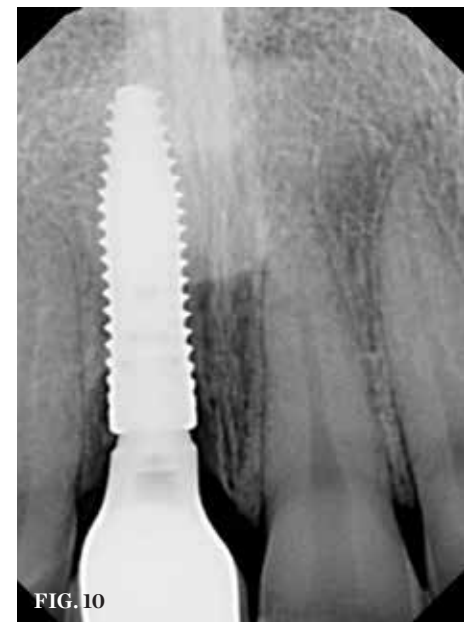
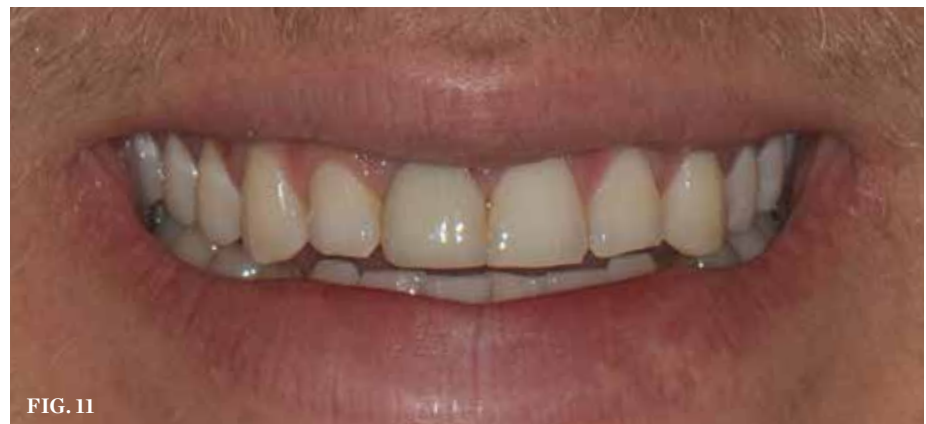
FIG. 8

The clinical examination revealed healthy soft tissues and excellent buccal contours mimicking the adjacent natural tooth (Figure 8 through Figure 11). The patient will continue periodontal maintenance visits twice yearly with his restorative dentist and annual examinations under the author’s care for 5 years to document soft- and hard-tissue healing.

incisal edge, a custom abutment (with 1-mm subgingival margins circumferentially) was fabricated, and the final crown was cemented with zinc phosphate cement using the copy abutment teflon-tape technique. This technique was employed to prevent subgingival cement remnants.<sup>11</sup>
